**ALCOA TECHNICAL**  
**BULLETIN**

ALCOA TECHNICAL  
**BULLETIN**

## Rim Flange Wear

## Mounting/demounting tires on Alcoa 22.5 Non-Symmetrical Wide Base Wheels

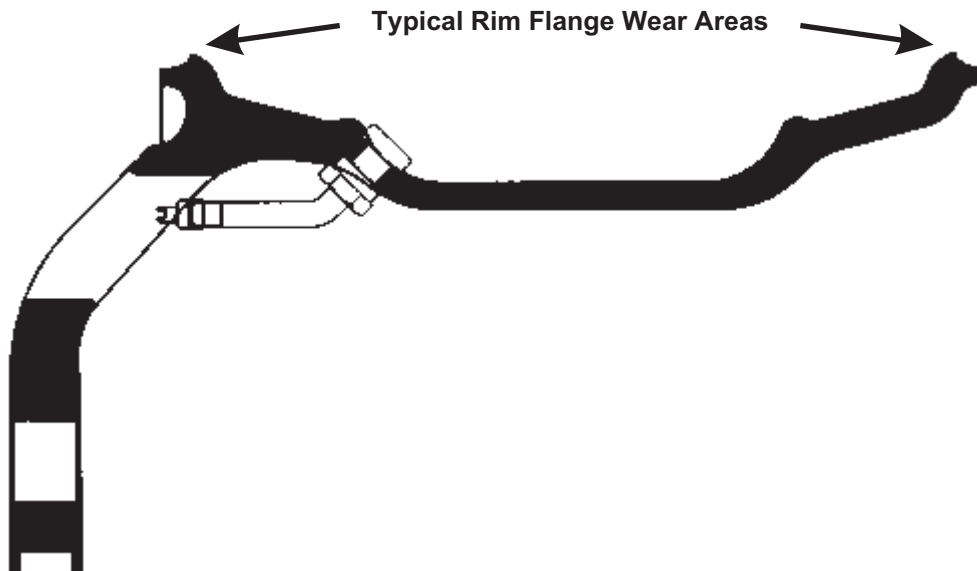
Aluminum wheels are often selected by transit fleets and other users because these wheels provide good looks, reduced weight and do not require periodic repainting like steel wheels. However, aluminum wheels should not be considered maintenance free. For example, the use of radial tires instead of bias ply tires in transit fleets and elsewhere has lead to an increase in the occurrence and severity of a normal condition commonly called "rim flange wear." This condition occurs as a result of the tire chafer and side wall wearing away the top of the rim flange of aluminum bus and truck wheels during use. As the tire rotates, the side wall bulges and contracts. The bulging happens when an area of the tire is under load, such as when located between the wheel and the road (the six o'clock position). The bulge contracts as the selected area of the tire rotates away from the road (toward the twelve o'clock position).

The cyclic loading of the tire and flexing of the tire side wall creates a “scrubbing” or erosion type wear on the wheel rim flange. Operating conditions such as load, temperature, tire inflation level, tire size, tire type and tire construction have significant impact on whether and at what rate rim flange wear occurs. In many instances, it is virtually nonexistent even after years of service. However, when rim flange wear does occur, it can create a sharp edge on the aluminum wheel which can in turn cause surface damage to tires, possibly reducing service life.

Moderate and even severe rim flange wear is a normal occurrence and is not a warranted condition. Wheel rim flanges should be inspected for wear and sharp edges as part of ongoing preventative maintenance. If wear is observed, it should be treated as a normal maintenance requirement.

The recommended method for treating rim flange wear is removal of the sharp edge by light sanding, grinding or filing. The actual amount of material to be removed is small and will vary based upon the condition of the wheel and the severity of the rim flange wear. This must be done in conjunction with Alcoa’s Rim Flange Wear Gauge – which Alcoa will supply to customers at no cost – to insure that adequate flange material remains to support the tire side wall and bead. Of course, Alcoa wheels continue to be warranted under normal use and load conditions as set forth in our warranty, provided these maintenance procedures have been followed.

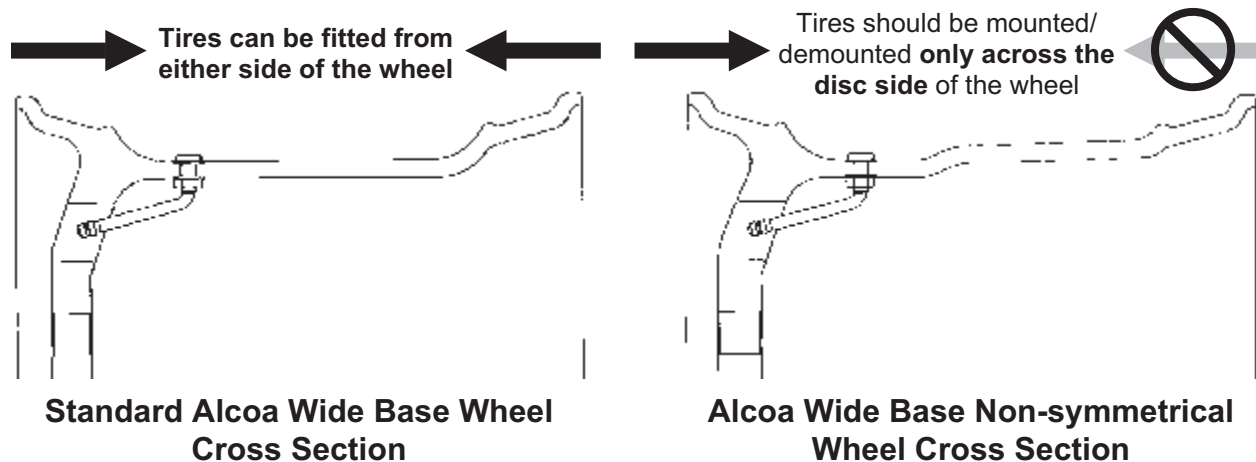
Alcoa has recently released a series of 22.5 forged aluminum Non-Symmetrical Wide Base wheels. These wheels feature a stepped wheel well which provides additional brake drum clearance. In order to minimize the possibility of bead damage, tires should be fitted and removed from the **disc side of wheel only**.

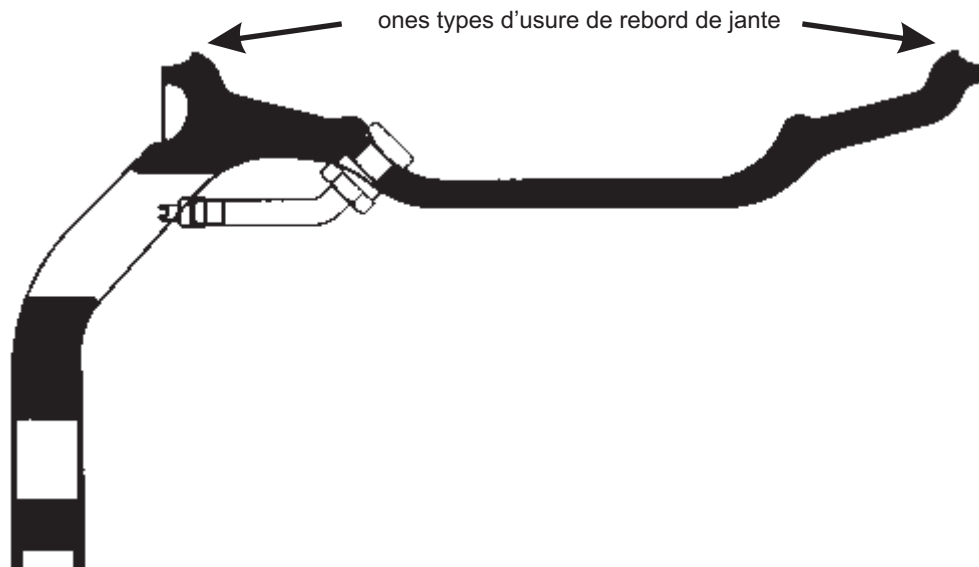
Les exploitants de parcs de véhicules de transport et autres usagers choisissent souvent les roues en aluminium pour leur belle apparence, leur faible poids et parce qu'il n'est pas nécessaire de les repeindre régulièrement comme les roues en acier. Toutefois, on aurait tort de penser que les roues en aluminium ne nécessitent aucun entretien. En effet, on a pu constater que l'utilisation de pneus à carcasse radiale au lieu de pneus à carcasse diagonale dans les parcs de véhicules de transport et ailleurs augmentait les risques et la gravité de ce qu'on appelle communément «usure du rebord de jante». Cette usure se produit lorsque la bande de renfort et la paroi latérale du pneu viennent frotter contre le rebord de jante des roues en aluminium d'autobus et de camions en motion. Pendant la rotation du pneu, la paroi latérale se bombe et se contracte. Le bombement apparaît lorsqu'une partie du pneu est sous charge, par exemple lorsqu'elle se trouve entre la roue et la route (dans la position 6 heures), et la contraction, lorsqu'elle s'éloigne de la route (vers la position 12 heures).

La charge cyclique du pneu et le fléchissement e sa paroi latérale créent une sorte d'usure par «frottement» ou d'érosion sur le rebord de jante de la roue. Les conditions d'utilisation telles que la charge, la température, le niveau de gonflage du pneu, sa dimension, son type et le matériau dont il est fait jouent un rôle très important dans l'apparition de l'usure du rebord de jante et la vitesse à laquelle elle apparaît. Souvent, cette usure ne se produit pas, même après des années de service, mais, lorsqu'elle se produit, elle peut favoriser l'apparition d'aspérités sur la roue en aluminium qui peuvent endommager la surface des pneus et réduire leur durée de vie.

Une usure moyenne ou même grave du rebord de jante est normale et n'est pas prise en charge par la garantie. Dans tout programme d'entretien préventif régulier des rebords de jante, on inspectera les roues pour déterminer leur degré d'usure et noter la présence d'aspérités. Si on constate une certaine usure, on la traitera comme une réparation normale.

La méthode recommandée pour traiter l'usure des rebords de jante consiste à retirer les aspérités par ponçage léger, meulage ou limage. La quantité de matériau à retirer est minime et dépendra de l'état de la roue et du degré d'usure du rebord de jante. On se servira pour ce faire de la jauge d'usure du rebord de jante Alcoa, que la compagnie fournit gratuitement à ses clients, pour s'assurer qu'il reste assez de rebord pour soutenir la paroi latérale et le talon du pneu. Il va sans dire que les roues Alcoa restent sous garantie en conditions d'utilisation et de charge normales, comme l'indique notre garantie, sous réserve, bien sûr, que les pratiques d'entretien aient été respectées.
