alcoa anglesea

environment report

august

2007

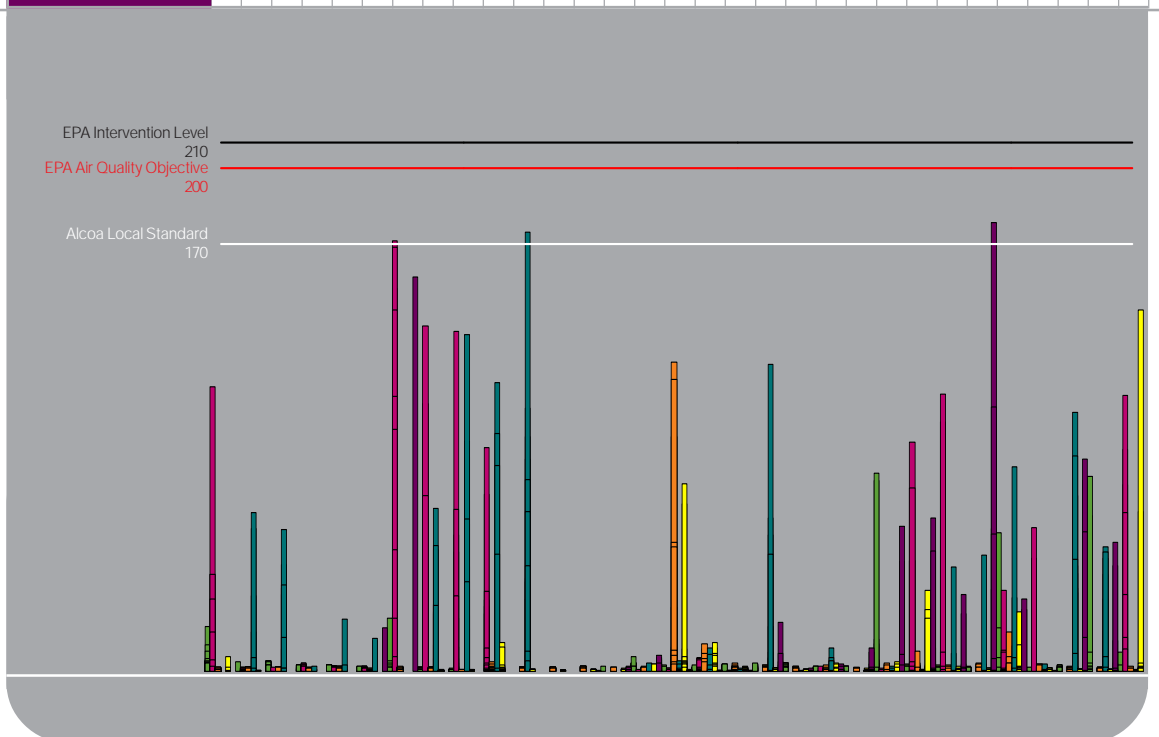
SO₂ Maximum 1 hour averages (ppb)

Date	1	2	3	4	5	6	7	8	9	10	11	12	13	14	15	16	17	18	19	20	21	22	23	24	25	26	27	28	29	30	31
Community Centre	18	4	4	3	3	2	21	2	1	-	-	-	-	2	6	3	3	3	3	3	2	2	79	3	2	2	55	2	3	78	8
Primary School	113	2	2	3	2	2	171	137	135	89	0	0	0	1	1	6	1	0	0	2	0	1	91	110	0	32	57	0	0	110	4
Mt Ingoldsby	2	2	2	2	2	1	2	2	1	4	2	2	2	3	123	11	3	3	2	3	2	4	8	2	3	16	3	2	2	2	1
Scout Camp	0	63	56	2	21	13	0	65	134	115	175	0	0	4	3	9	0	122	1	10	0	2	1	41	46	81	3	103	49	1	156
Camp Wilkin	6	0	0	0	0	0	0	1	1	12	1	1	1	3	74	11	2	1	1	4	1	4	32	1	1	24	1	1	1	144	2
Camp Road	-	-	-	-	-	-	-	157	-	-	-	-	-	0	2	7	1	1	0	20	0	3	9	58	61	30	178	29	0	84	51

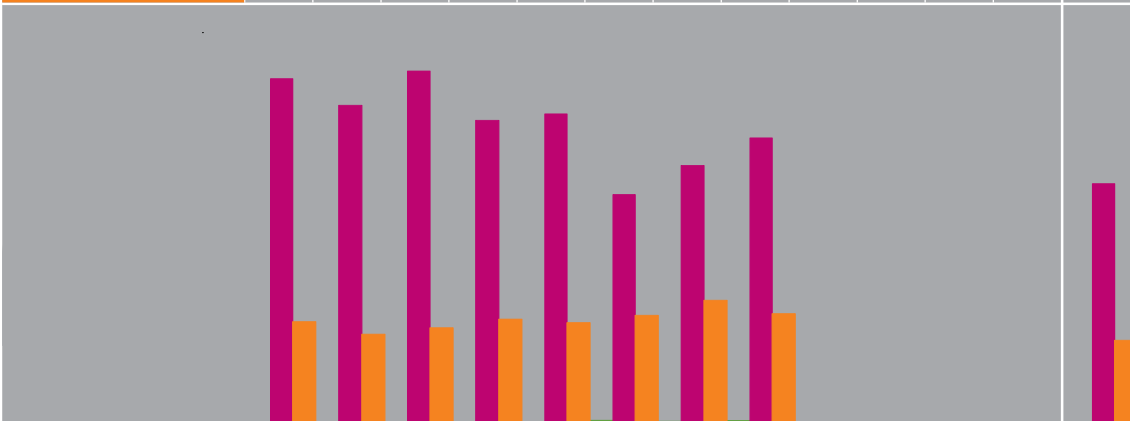
WATER WATER USAGE PER MONTH (ML)

Date	JAN	FEB	MAR	APR	MAY	JUNE	JULY	AUG	SEPT	OCT	NOV	DEC	TOTAL
Town Water	0.7	0.7	0.9	1.1	0.9	2.3	1.7	1.9					10.2
Bore Water	274	253	280	241	246	182	205	227					1908
Mine Water	81	71	76	83	80	86	98	87					662

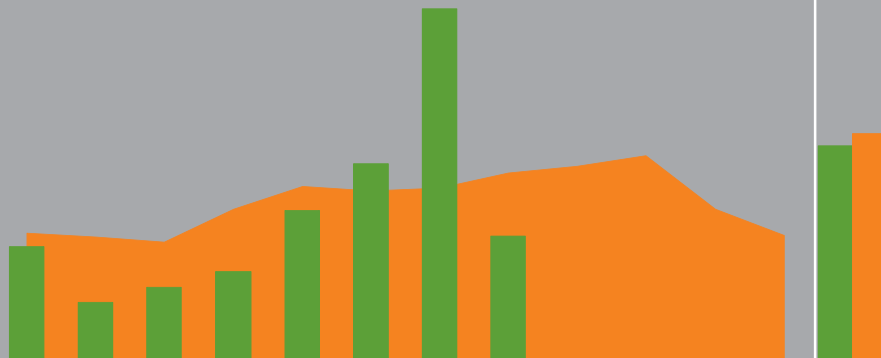
RAINFALL (mm)

Month	JAN	FEB	MAR	APR	MAY	JUNE	JULY	AUG	SEPT	OCT	NOV	DEC	TOTAL
2007 Rainfall	40.0	20.2	25.6	31.0	52.8	69.2	124.0	43.6					406.4
1968-2006 Average	44.6	43.3	41.5	53.1	61.2	59.6	60.6	65.8					429.7

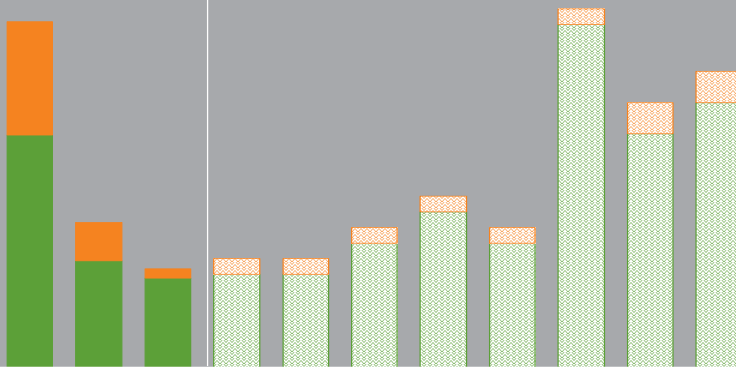
TOWN WATER USE (ML)

2000	2006	2007	JAN	FEB	MAR	APR	MAY	JUN	JUL	AUG	SEP	OCT	NOV	DEC
Process	23.9	11.0	9.2	0.6	0.6	0.8	1.0	0.8	2.2	1.5	1.7				
Amenity	11.6	3.8	1.0	0.1	0.1	0.1	0.1	0.1	0.1	0.2	0.2

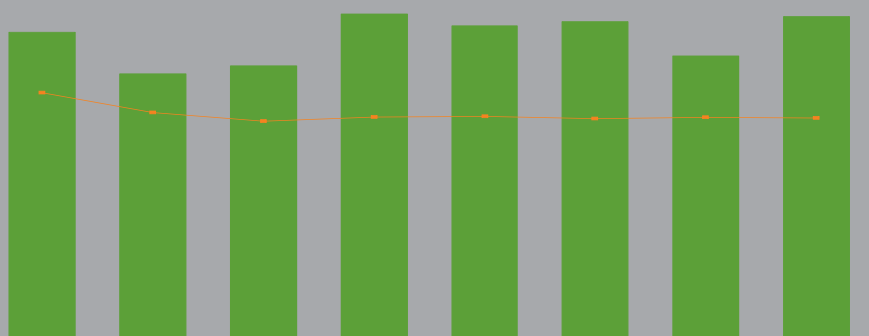
GREENHOUSE GAS (GHG) TOTAL (Mt) & GHG EMISSION EFFICIENCY (t/MWh)

1990	2000	2001	2002	2003	2004	2005	2006	2007
GHG Mt	1.42	1.23	1.27	1.50	1.45	1.47	1.31	1.49	1.38
◆ GHG. t/MWh	1.34	1.24	1.19	1.21	1.21	1.20	1.21	1.20	1.18
