natural goodness
getting close to nature naturally

anglesea environment report

JULY 2006

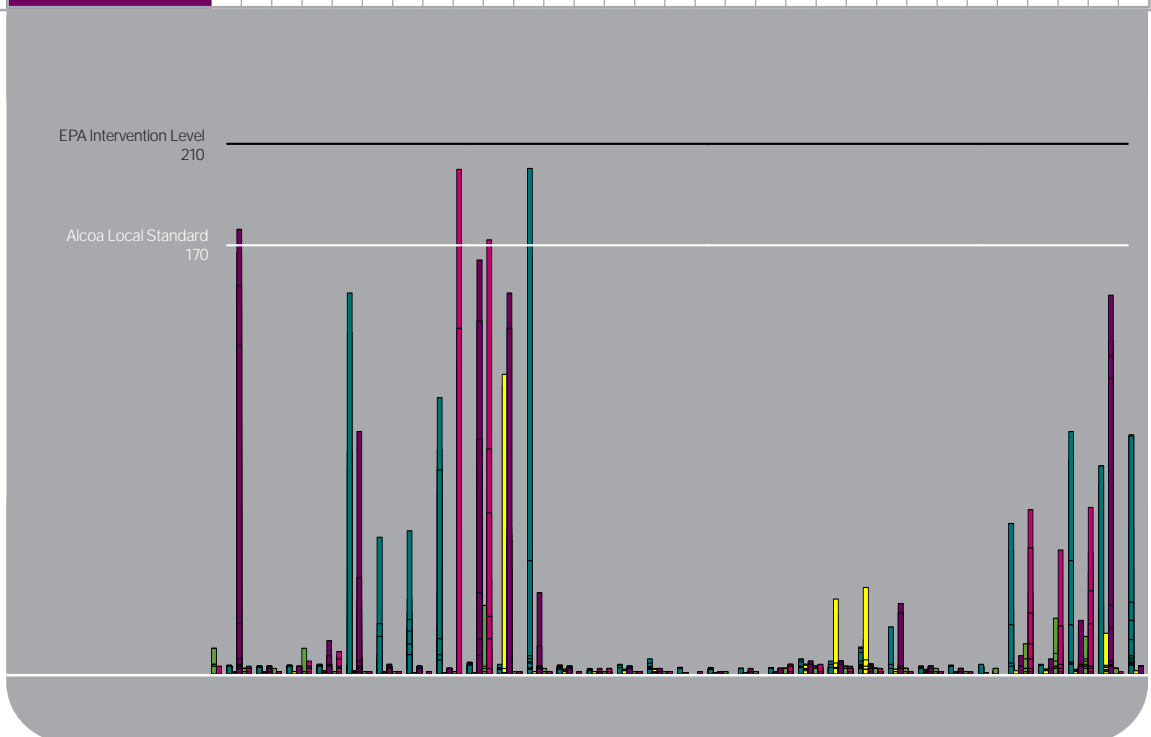
Ambient Monitors																															
SO ₂ Maximum 1 hour averages (ppb)																															
Date	1	2	3	4	5	6	7	8	9	10	11	12	13	14	15	16	17	18	19	20	21	22	23	24	25	26	27	28	29	30	31
Community Centre	10	2	2	10	1	1	1	0	1	27	1	2	0	1	1	1	0	1	1	2	3	3	2	2	2	1	2	12	22	15	2
Primary School	3	3	1	5	9	1	1	1	200	172	1	1	1	2	1	1	1	0	0	4	4	3	2	1	1	1	0	65	49	66	1
Mt Ingoldsby	-	-	-	-	-	-	-	-	-	-	-	-	-	-	-	-	-	-	-	-	-	-	-	-	-	-	-	-	-	-	0
Scout Camp	3	3	4	4	151	54	57	109	5	4	200	4	2	4	6	2	2	2	2	6	5	11	19	3	3	4	60	4	96	83	95
Camp Wilkin	1	1	1	1	1	1	1	1	1	119	1	2	1	2	2	1	1	1	1	4	29	34	2	2	1	0	1	2	2	16	1
Camp Road	176	3	3	13	96	4	3	2	164	151	32	3	2	3	2	0	1	1	2	5	5	4	28	3	2	0	7	6	21	150	3

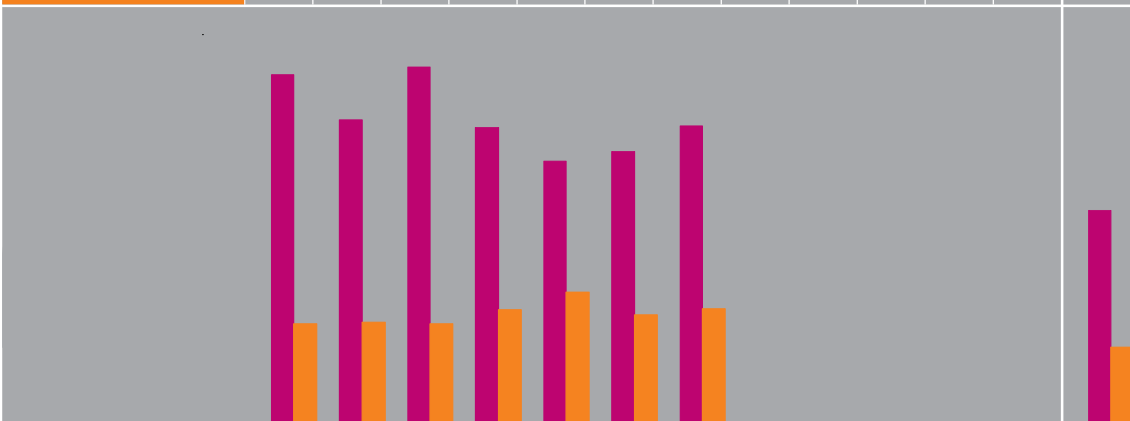
WATER WATER USAGE PER MONTH (ML)

Date	JAN	FEB	MAR	APR	MAY	JUNE	JULY	AUG	SEPT	OCT	NOV	DEC	TOTAL
Town Water	1.0	1.0	1.0	1.5	1.6	0.8	1.0						7.9
Bore Water	279	243	285	237	210	218	238						1710
Mine Water	81	82	81	92	106	88	93						623

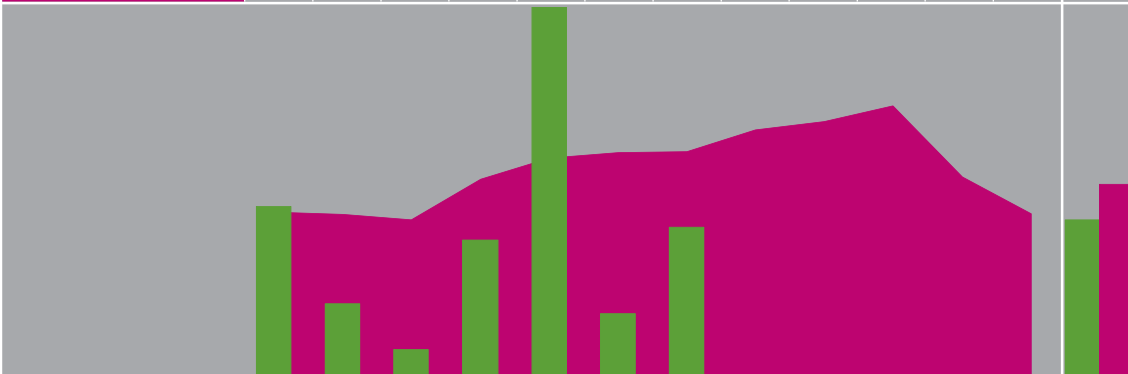
RAINFALL (mm)

Month	JAN	FEB	MAR	APR	MAY	JUNE	JULY	AUG	SEPT	OCT	NOV	DEC	TOTAL
2006 Rainfall	46.2	19.6	7.3	37.1	129.4	17.0	40.6						297.2
1968-2005 Average	44.6	43.9	42.5	53.5	59.3	60.8	60.8						365.7

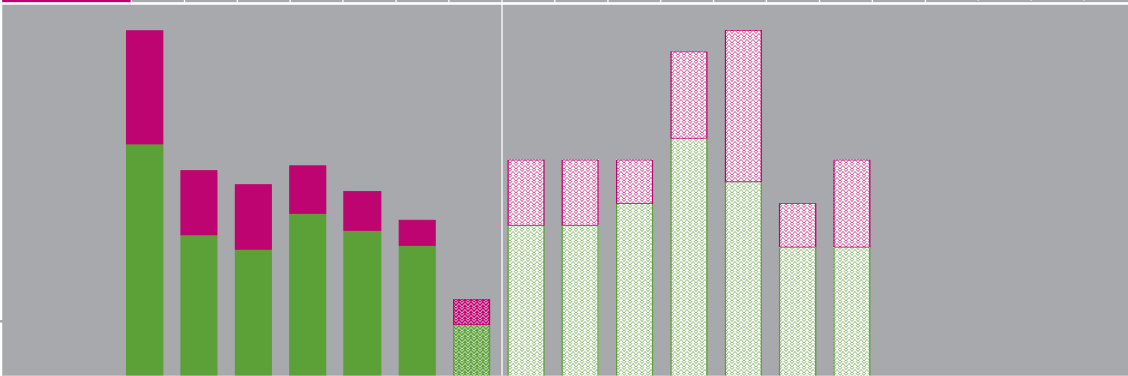
TOWN WATER USE (ML)

2000	2001	2002	2003	2004	2005	2006	JAN	FEB	MAR	APR	MAY	JUN	JUL	AUG	SEP	OCT	NOV	DEC
Process	23.9	14.6	13.1	16.7	15.0	13.5	5.4	0.7	0.7	0.8	1.1	0.9	0.6	0.6					
Amenity	11.6	6.6	6.6	5.0	4.0	2.6	2.5	0.3	0.3	0.2	0.4	0.7	0.2	0.4

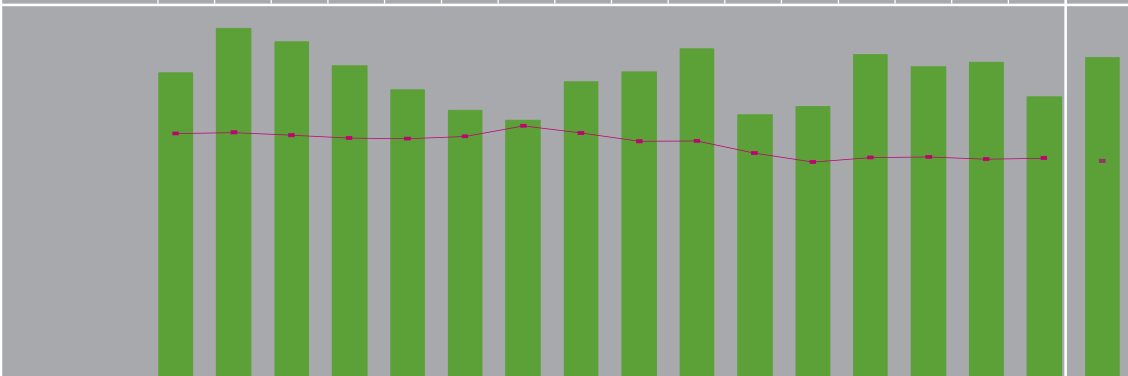
GREENHOUSE GAS (GHG) TOTAL (Mt) & GHG EMISSION EFFICIENCY (t/MWh)

1990	1991	1992	1993	1994	1995	1996	1997	1998	1999	2000	2001	2002	2003	2004	2005	2006
GHG Mt	1.42	1.62	1.56	1.45	1.34	1.25	1.20	1.38	1.42	1.53	1.23	1.27	1.50	1.45	1.47	1.31	1.49
◆ GHG t/MWh	1.34	1.35	1.33	1.32	1.31	1.33	1.38	1.34	1.30	1.30	1.24	1.19	1.21	1.21	1.20	1.21	1.19
