# Community update

Anglesea

## Major rehabilitation milestones achieved in 2020

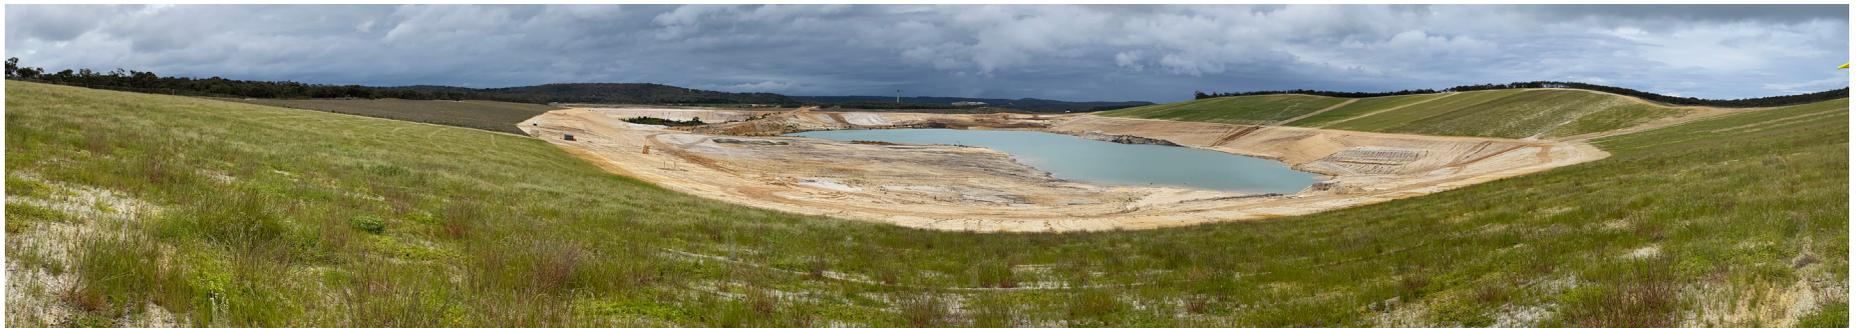
A view from the south-west corner of the mine highlighting the completed earthworks, thriving grasslands and developing waterbody.

- completion of major earthworks including reprofiling of the western and southern slopes after an almost two-year program of works;
- completion of 53 hectares of native wallaby grass hydroseeding on the southern slopes of the mine;
- continued establishment of the topsoil subsoil vegetation on the western slopes of the mine;
- relocation of 1.2 kilometres of Coalmine Rd;
- installation of surface water drains and additional groundwater monitoring wells around the periphery of the mine; and
- approval from Southern Rural Water to conduct a 12-month groundwater pumping test as part of the mine water filling strategy.
