**ALCOA OF AUSTRALIA LIMITED**  
**BUSHFIRE MITIGATION AND LINE CLEARANCE PLANS**  
**2014/2015**

Rev D as submitted 27 06 2014

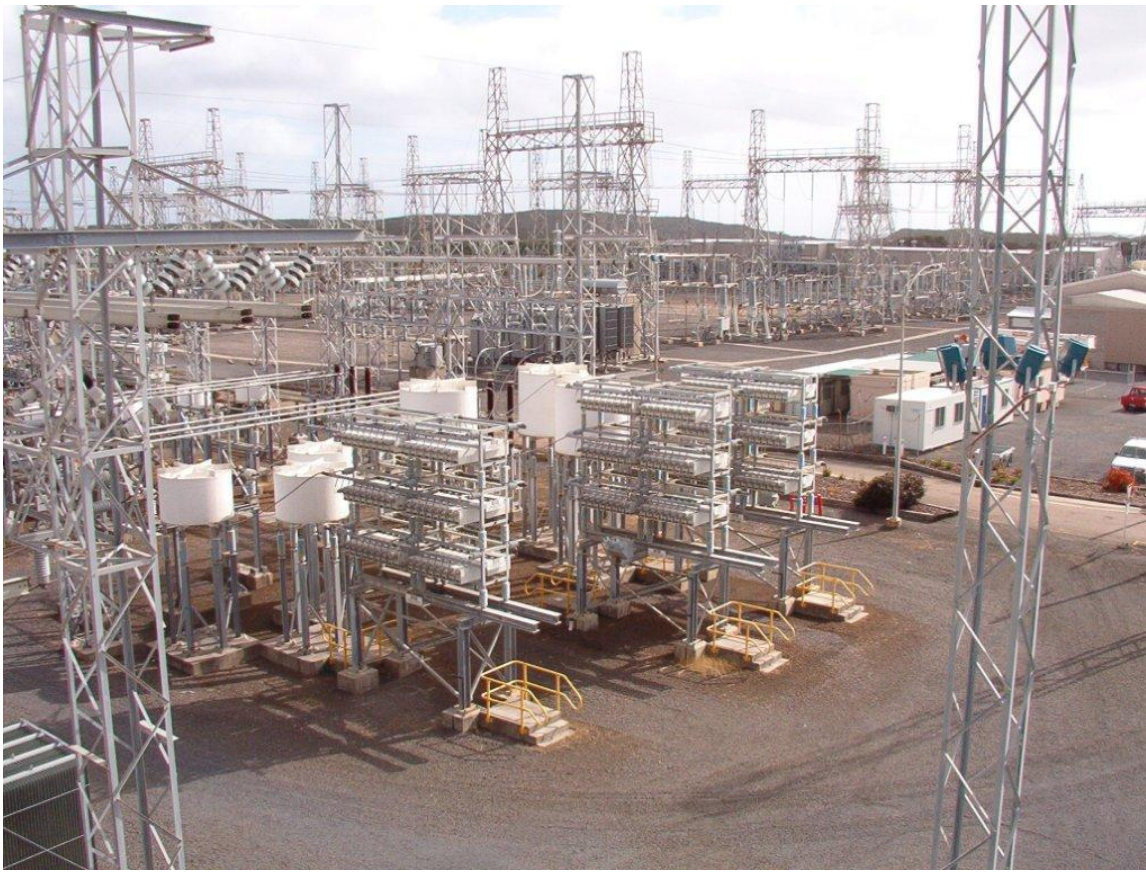
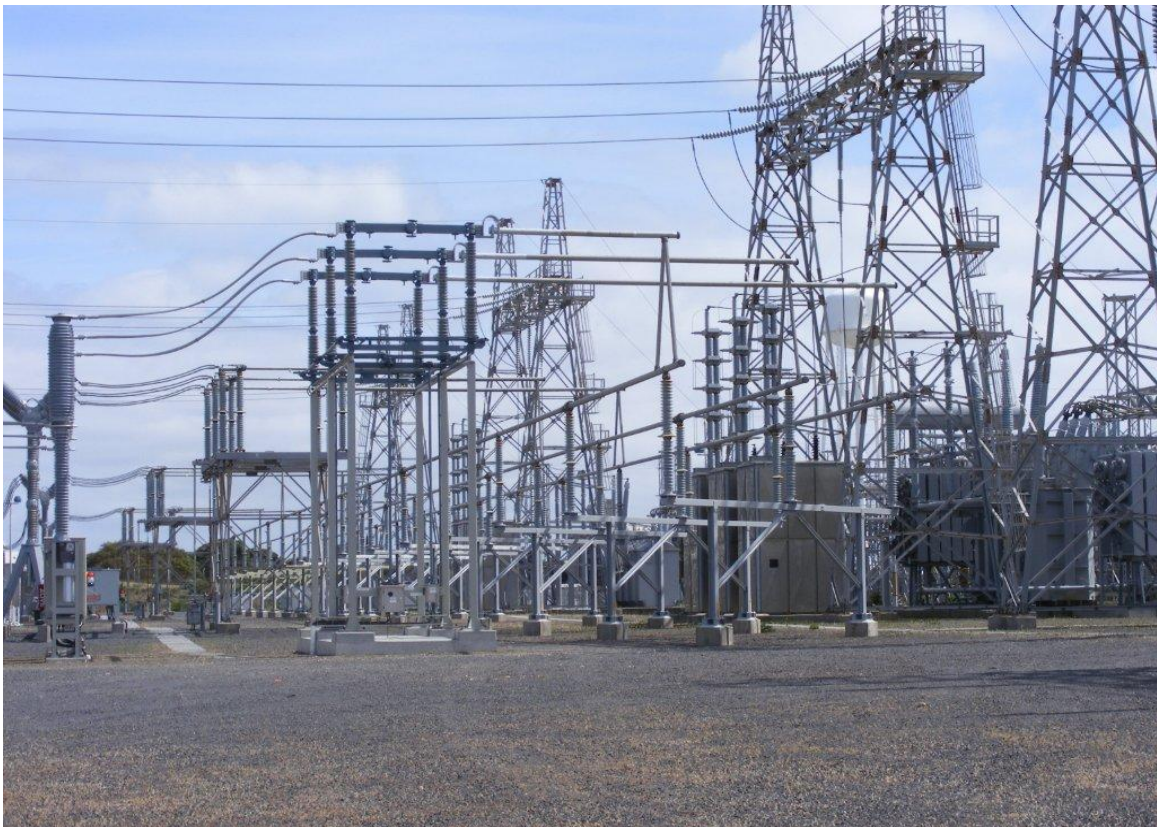
**PORTLAND MAIN SWITCHYARD ILLUSTRATING LACK OF SIGNIFICANT VEGETATION**

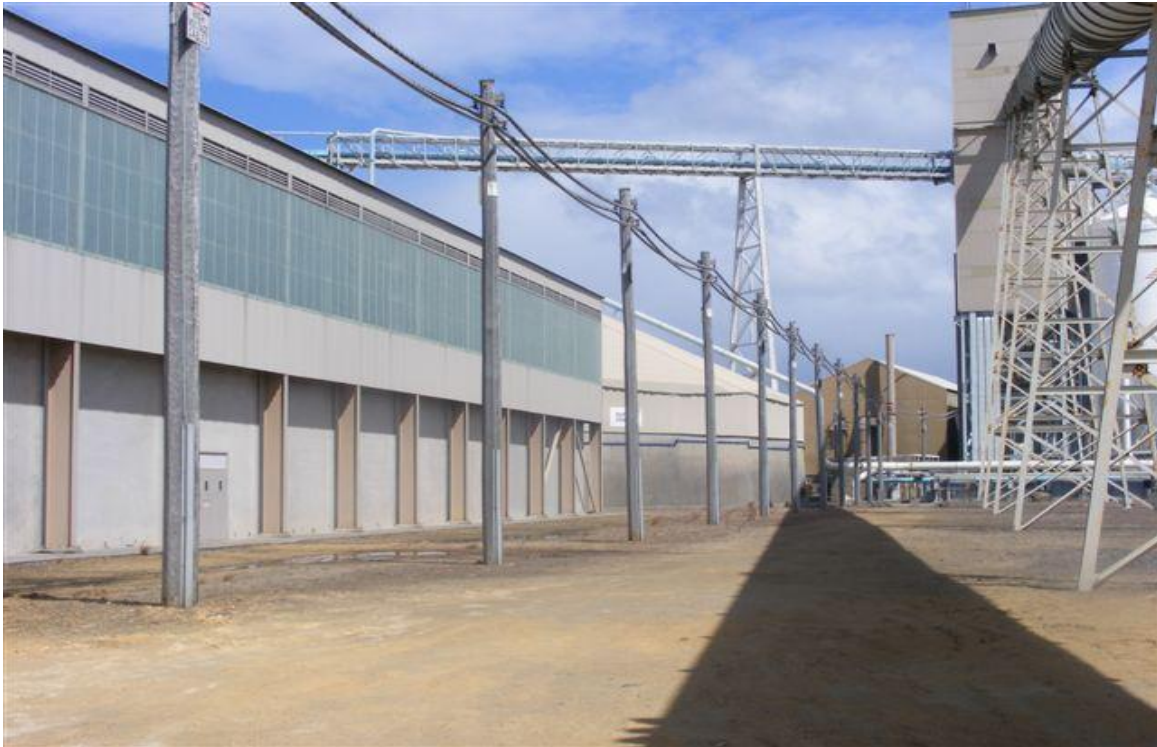
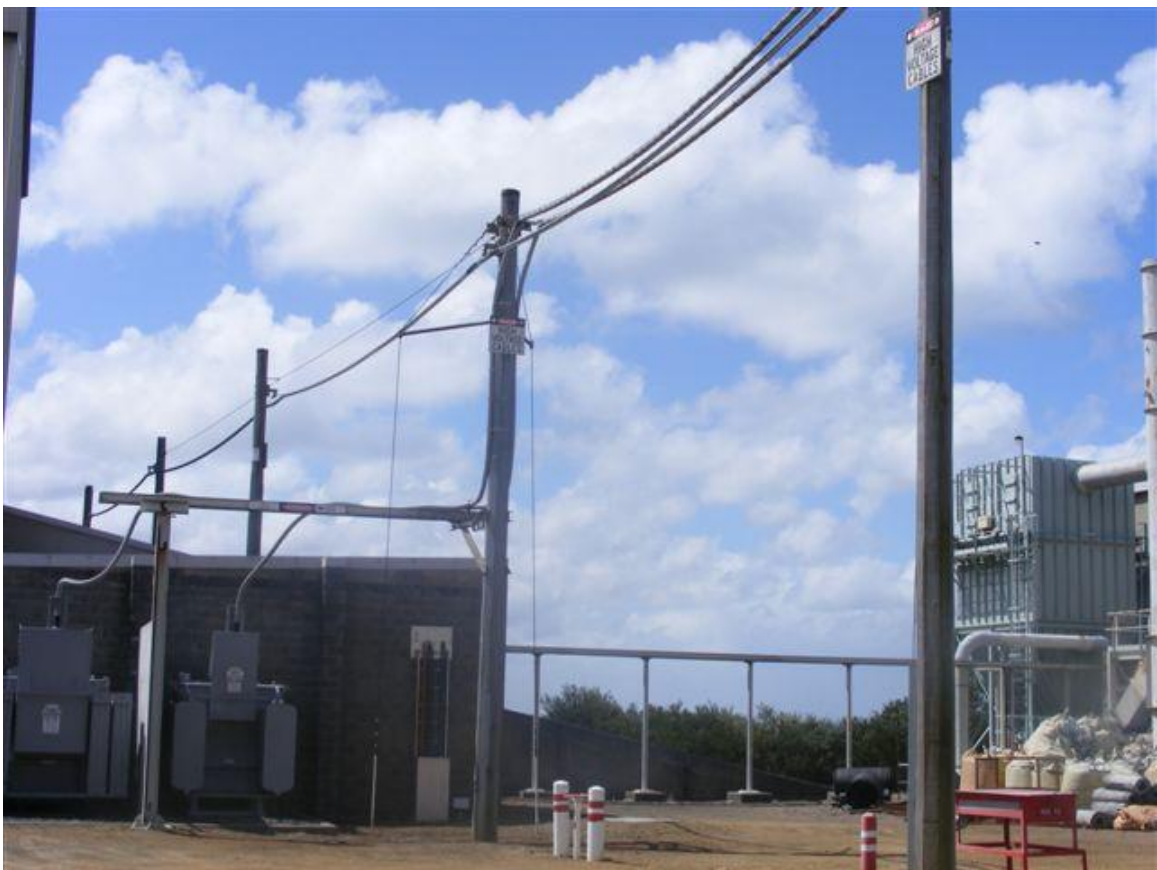
**PORTLAND 22kV AERIAL LINES SHOWING THE INSULATED CABLE CONSTRUCTION AND LACK OF SIGNIFICANT VEGETATION**

Alcoa has favoured insulated construction for its distribution lines for many years. Several of its employees are CFA members and Alcoa has a good working relationship with the local CFA units. It uses its CFA connection to ensure that the hazard around its distribution lines are minimised.
